Manhole Inspection Summary

Manhole # **S15GG1020MH**

Location Address: **PALL MALL RD** Cross Street: **QUANTICO AVE**

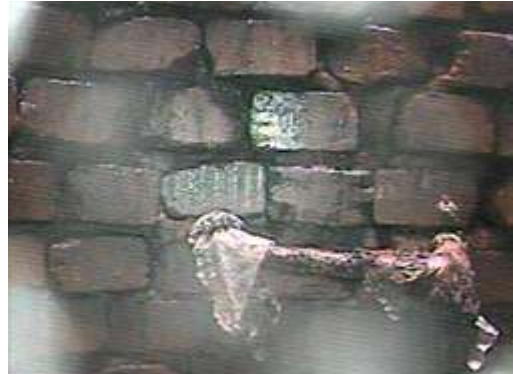
Defect 1

Steps Count: **6** Missing: **0** ☒ **Corroded**

Surcharge ☒ **Evidence Of Surcharge** Depth: **5** (ft.) ☐ Active Surcharge Present

EVIDENCE OF SURGE AND
CORRODED STEP

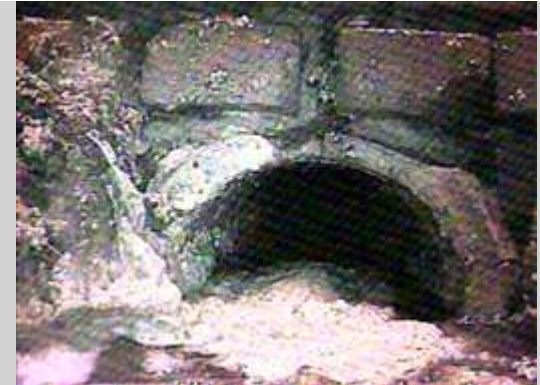
12 O'Clock Outflow

8 in. Circular Gravity Sewer
Pipe Out @ 12 O'Clock

Pipe Height: (in.) Direct
Pipe Material: **Clay** ☐ Pipe Lined
Invert Depth: **14.12** (ft.) Flow Characteristics: **Slow**
Deposits: ☐ None ☒ **Mud** ☒ **Sludgy** ☒ **Debris** ☒ **Grease**
Silt Depth: **6** (in.) Deposits Extent: **Heavy**
Infiltration: **None** Pipe Seal Cond: **Broken**

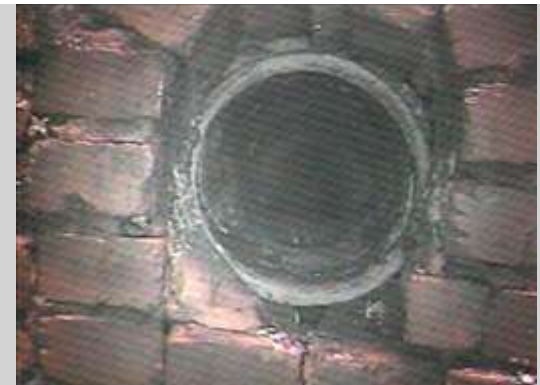
3 O'Clock Inflow

8 in. Circular Gravity Sewer
Pipe In @ 3 O'Clock

Pipe Height: (in.) Direct
Pipe Material: **Clay** ☐ Pipe Lined
Invert Depth: **10.30** (ft.) Flow Characteristics: **Slow**
Deposits: ☐ None ☒ **Mud** ☒ **Sludgy** ☒ **Debris** ☒ **Grease**
Silt Depth: **6** (in.) Deposits Extent: **Heavy**
Infiltration: **None** Pipe Seal Cond: **Cracked**

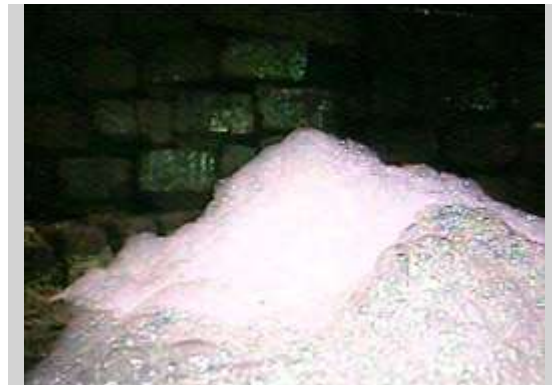
Drop In @ 3 O'Clock

Drop: **Outside Direct**

Inv Depth: **13.92** (ft.)

Drop Condition: **Open**

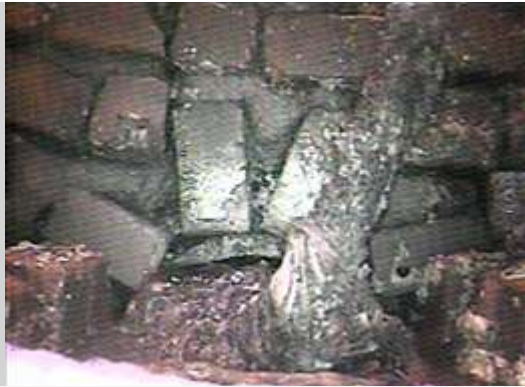
6 O'Clock Inflow

Invert Depth: **14.05** (ft.) Flow Characteristics: **Slow**

Deposits: ☐ None ☒ **Mud** ☒ **Sludge** ☒ **Debris** ☒ **Grease**

Silt Depth: **6** (in.) Deposits Extent: **Heavy**

Infiltration: **None** Pipe Seal Cond: **Unknown**

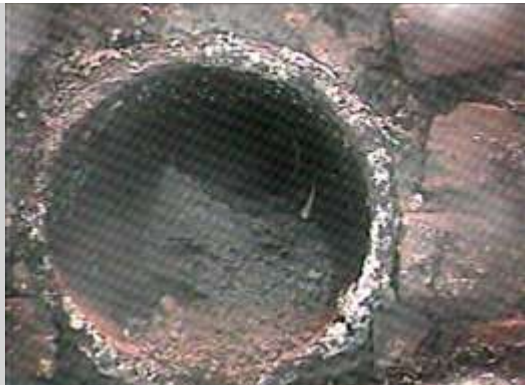
9 O'Clock Inflow

Invert Depth: **11.10** (ft.) Flow Characteristics: **Slow**

Deposits: ☐ None ☒ **Mud** ☒ **Sludge** ☒ **Debris** ☒ **Grease**

Silt Depth: **6** (in.) Deposits Extent: **Heavy**

Infiltration: **None** Pipe Seal Cond: **Broken**

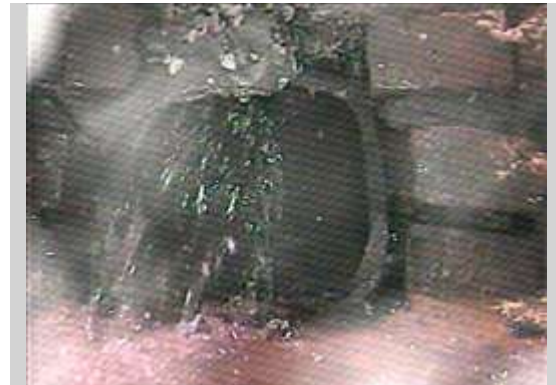
Drop In @ 9 O'Clock

Drop: **Outside Direct**

Inv Depth: **13.83** (ft.)

Drop Condition: **Open**
